BASF Wyandotte

31st Street Landfill - Huntington

IW-5959-79

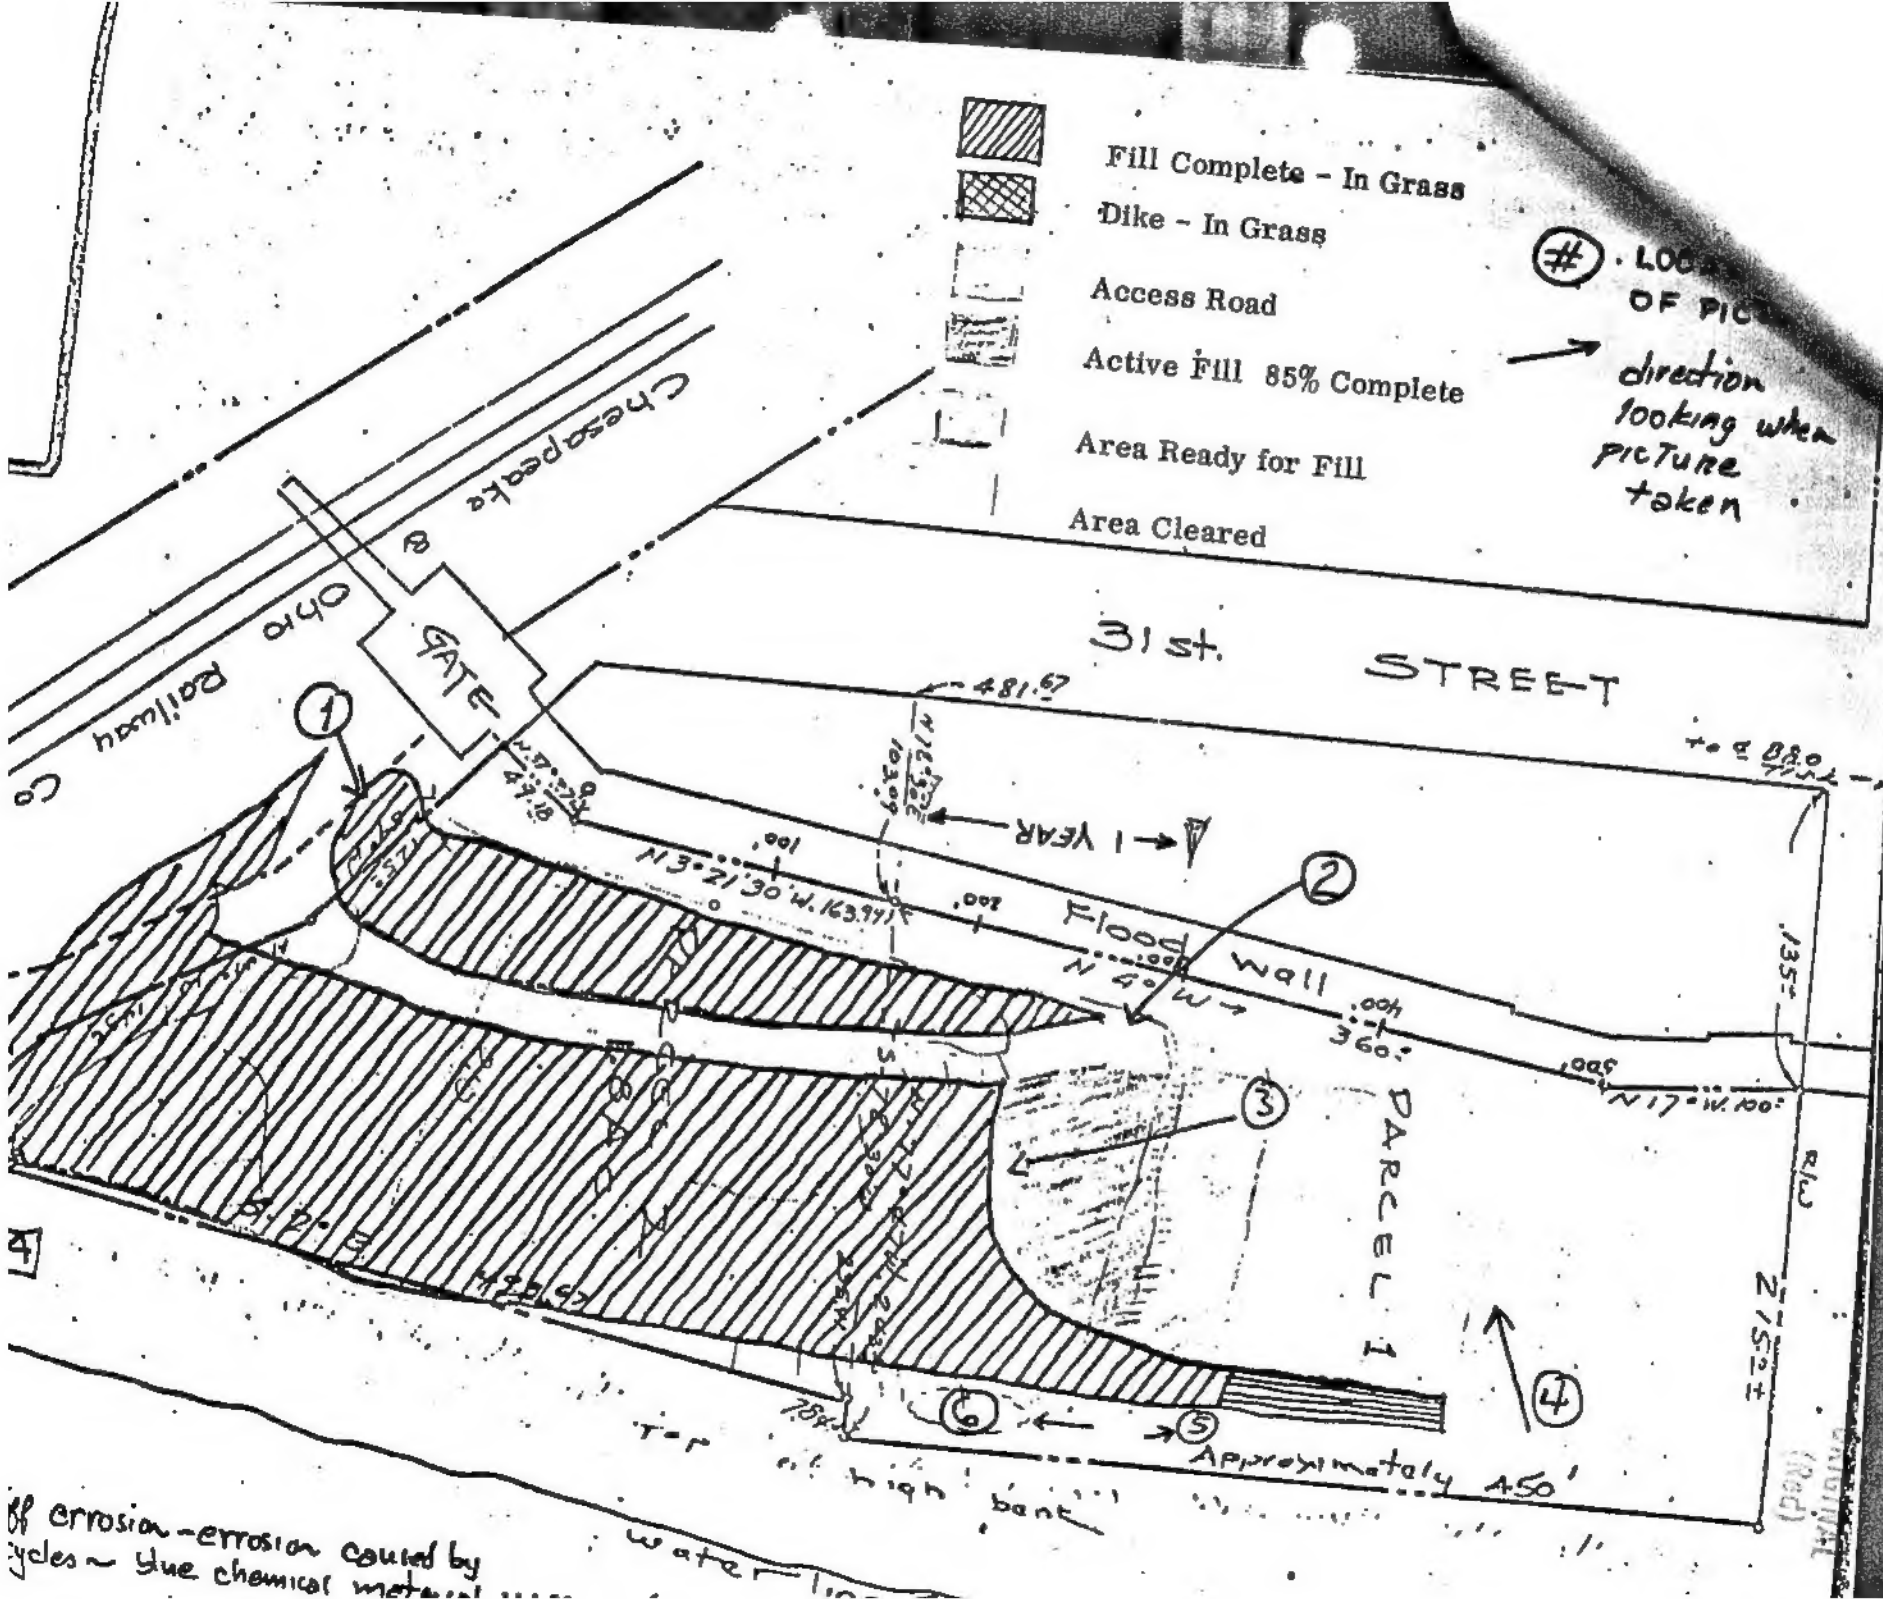
Fill Complete - In Grass

Dike - In Grass

Access Road

Active Fill 85% Complete

Area Ready for Fill

Area Cleared

erosion - erosion caused by cycles - due chemical material
